VUF-1015
FINAL REPORT

VELA UNIFORM PROJECT SHOAL

PRESHOT AND POSTSHOT STRUCTURE SURVEY
Holmes & Narver, Inc.

December 1963

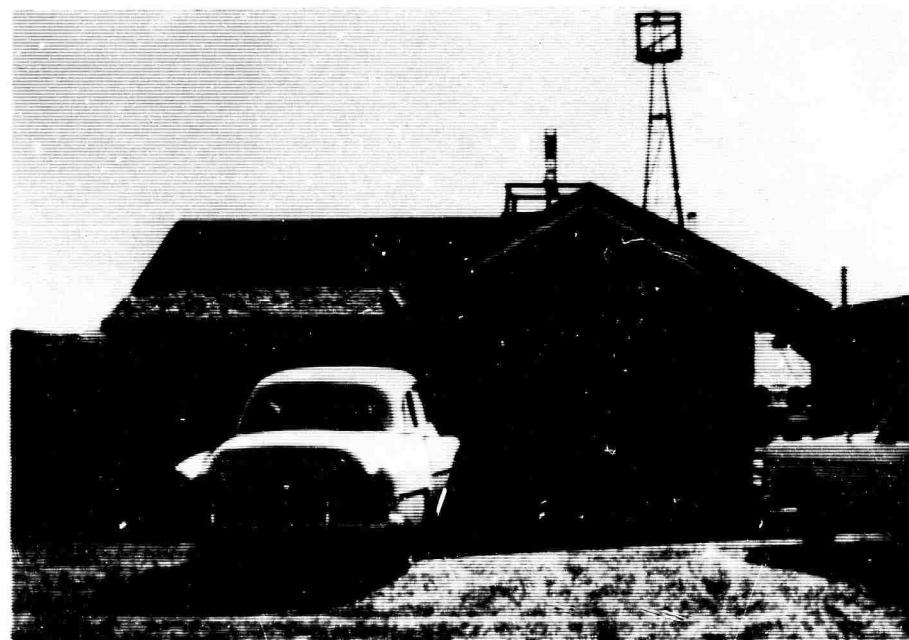
- 2-2 Residence (See photo 2-2) This is a 30 x 30-foot three bedroom, wood frame structure that was built about 1956. No damage was noted as a result of the postshot survey.

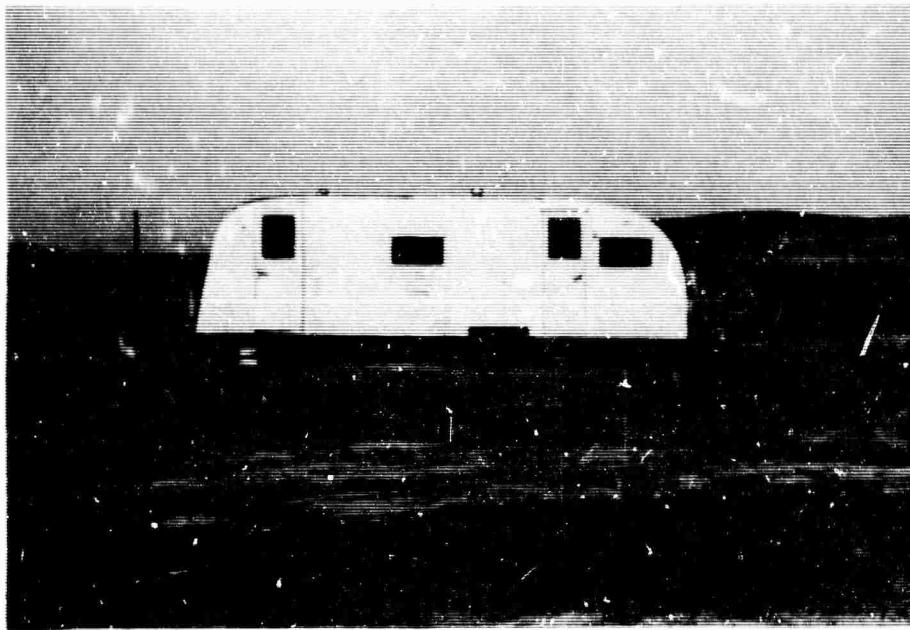
Photo No. 2-4 - Preshot - September 23, 1963

A trailer identified by Serial No. 2-4 had been removed from the location and was not present at shot time; therefore, no postshot photograph was taken. Another trailer which is identified by Serial No. 22-5 was burned down during the weekend of October 19, 1963, according to the owners. A detailed report of these changes is included in Appendix A. No other physical changes were observed.

- 2-3 Trailer (See photo 2-3) This is a 30-foot long x 8-foot wide aluminum-covered trailer. No damage was noted as a result of the postshot survey.
- 2-4 Road Crew Trailer (See photo 2-4) This temporary road crew trailer was on the property when it was visited on September 23, 1963, but had been removed when the property was visited on October 26, 1963.

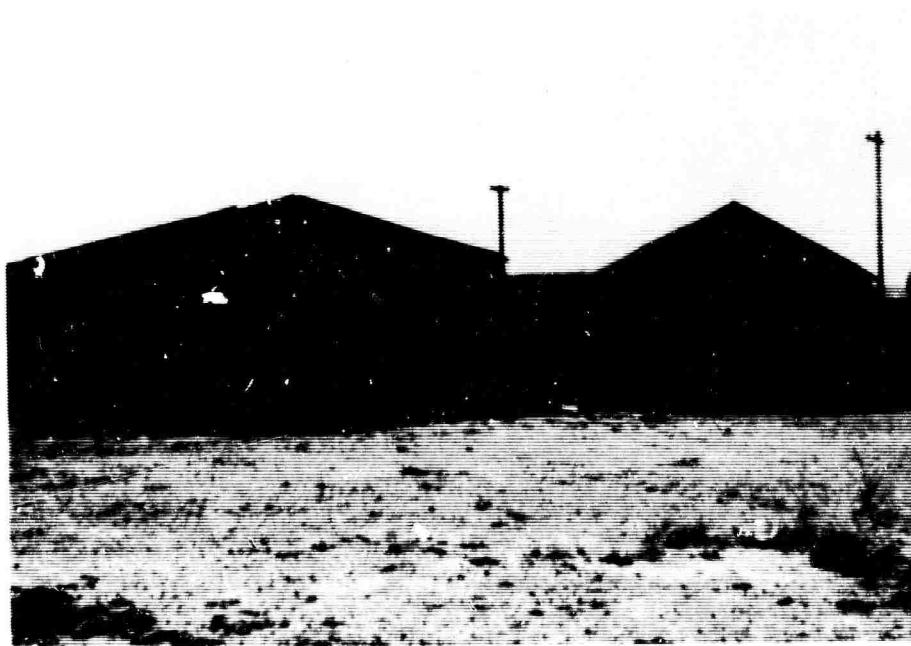
- 2-5 Power, Pump and Storage Building (See photo 2-5) The westerly structure, on the left in the photos, was built about 1945. It is unpainted, but is otherwise in fair condition except for some

warping of the wood and a broken hinge on the west door. The easterly structure is under construction. No damage was noted as a result of the postshot survey.

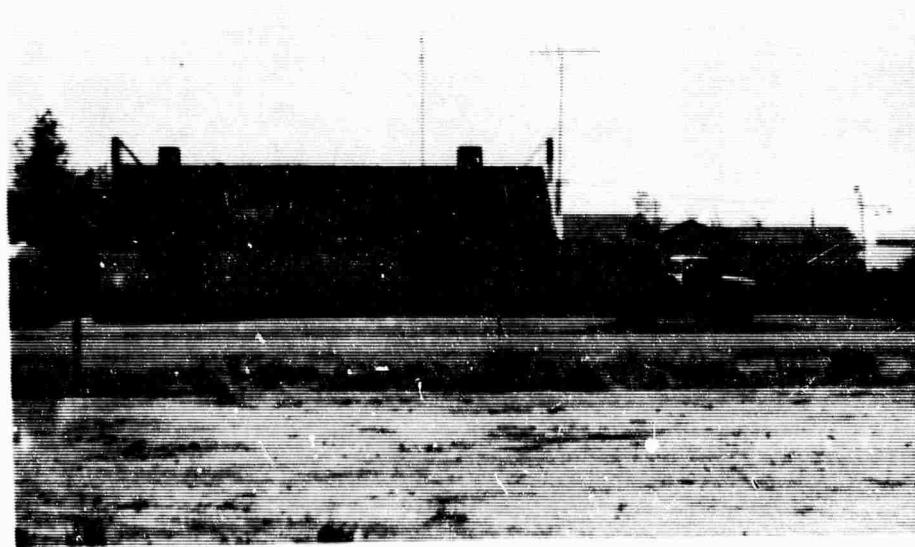
3-1 Bar and Restaurant (See photos 3-1(1) through 3-1(10)) Bar and restaurant, wood frame and stucco structure. Stucco is generally covered with small cracks. The original structure was displaced from its foundations in 1954 by an earthquake. The original structure is of uncertain age, but it was completely rebuilt about 1957. The main room is a bar, restaurant, and gift shop with many shelves and counters upon which are glasses, bottles, gift items and other miscellaneous items. The walls and ceiling on the interior are covered with knotty pine paneling. The liquor storage room has cleated pine shelves and liquor stock for the bar. No damage was noted as a result of the postshot survey.

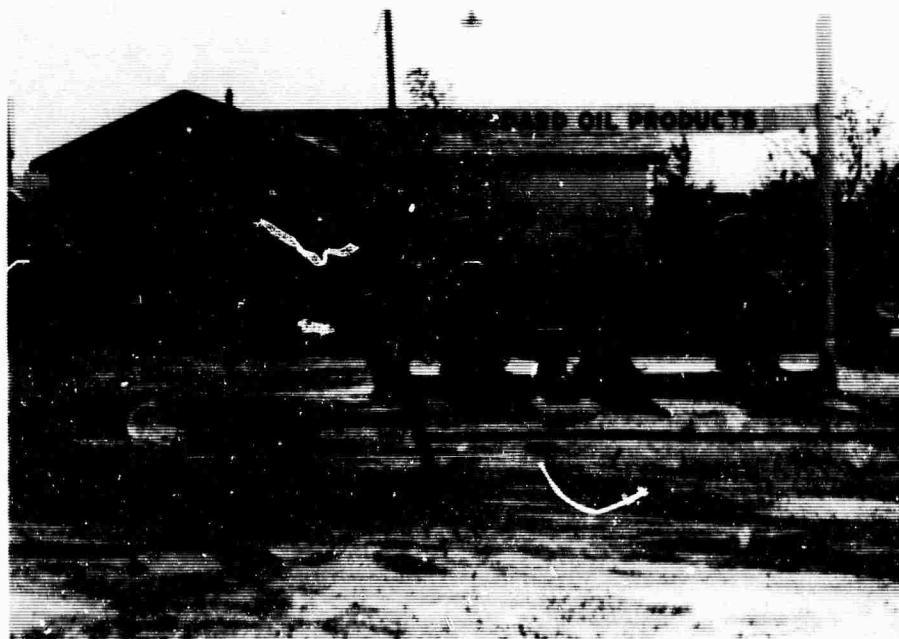
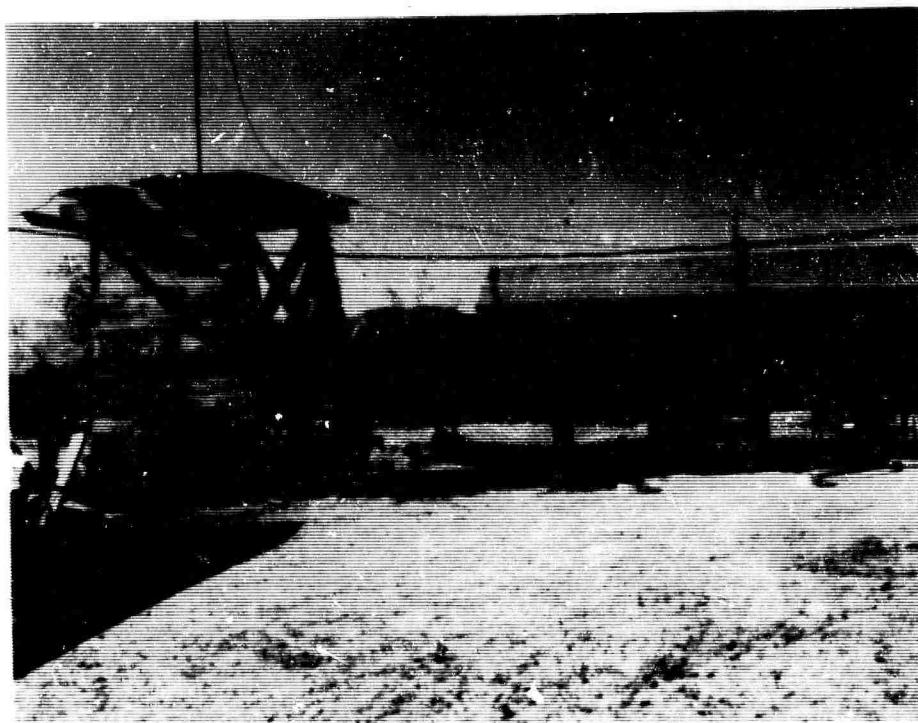
3-2 Garage (See photos 3-2(1) and 3-2(2)) 24 x 30-foot concrete block structure built about 1953. There are three gasoline pumps. There is a wood tower or platform structure supporting the T.V. antenna. This structure is roughly built of planks and boards. See photo 3-2(2). No damage was noted as a result of the postshot survey.

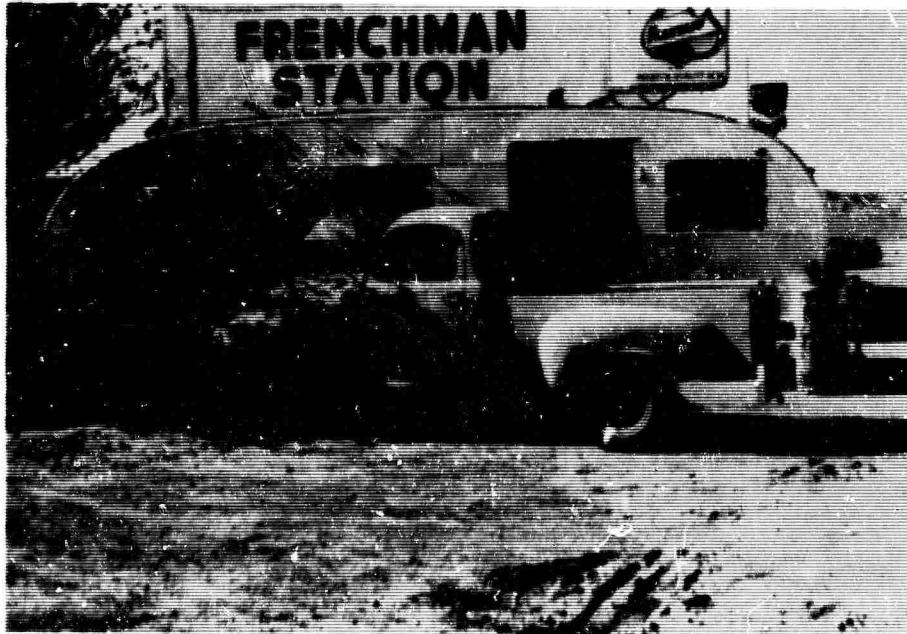
Photo No. 3-4 (1) - Preshot - September 23, 1963

3-4 Trailer (See photos 3-4(1) and 3-4(2)) This is a 25-foot long metal covered trailer. No damage was noted as a result of the postshot survey.

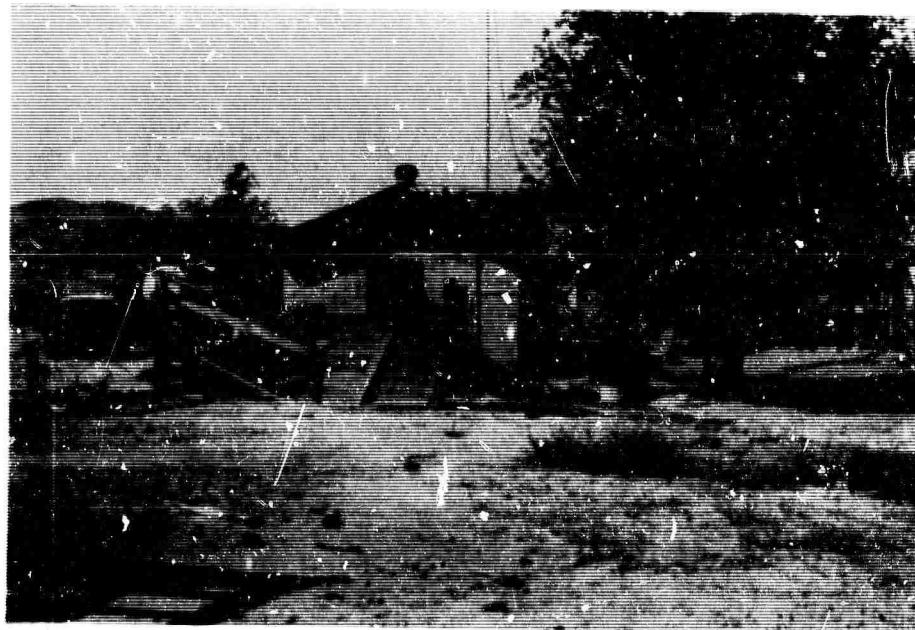
Photo No. 3-5 (1) - Preshot - September 23, 1963

3-5 Pump house (See photos 3-5(1) through 3-5(4)) This is a 15 x 20-foot concrete masonry pump house built about 1953. AZ 254° clockwise from magnetic north. No damage was noted as a result of the postshot survey.

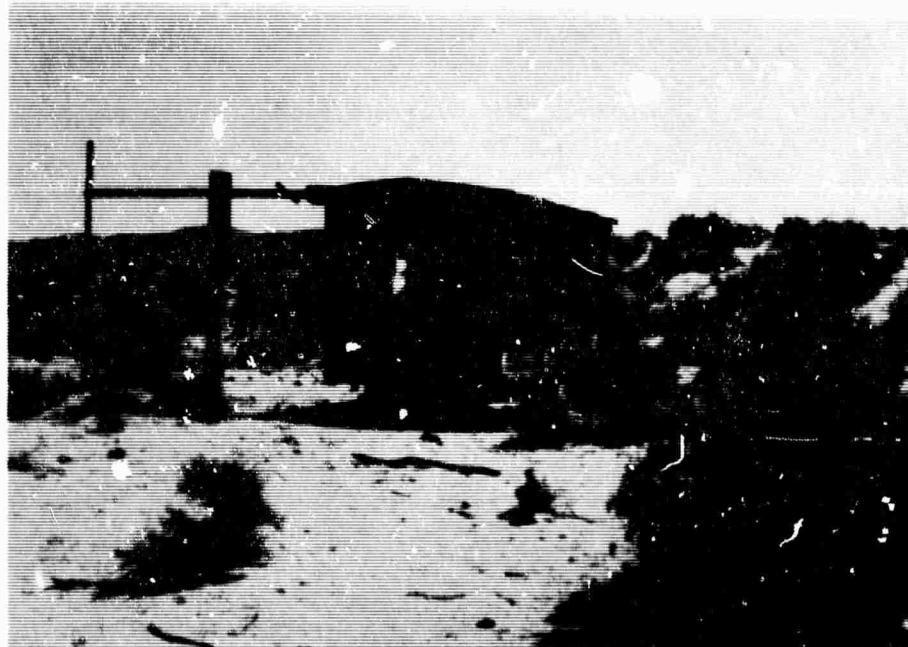
Photo No. 9-1 - Preshot - September 23, 1963

9-1 Shack (See photo 9-1) This 8 x 15-foot wood shack is about 40 years old and abandoned. Siding is unpainted, badly weathered and warped. Windows are all missing. Interior is completely gutted and floor is covered with trash. No damage was noted as a result of the postshot survey.

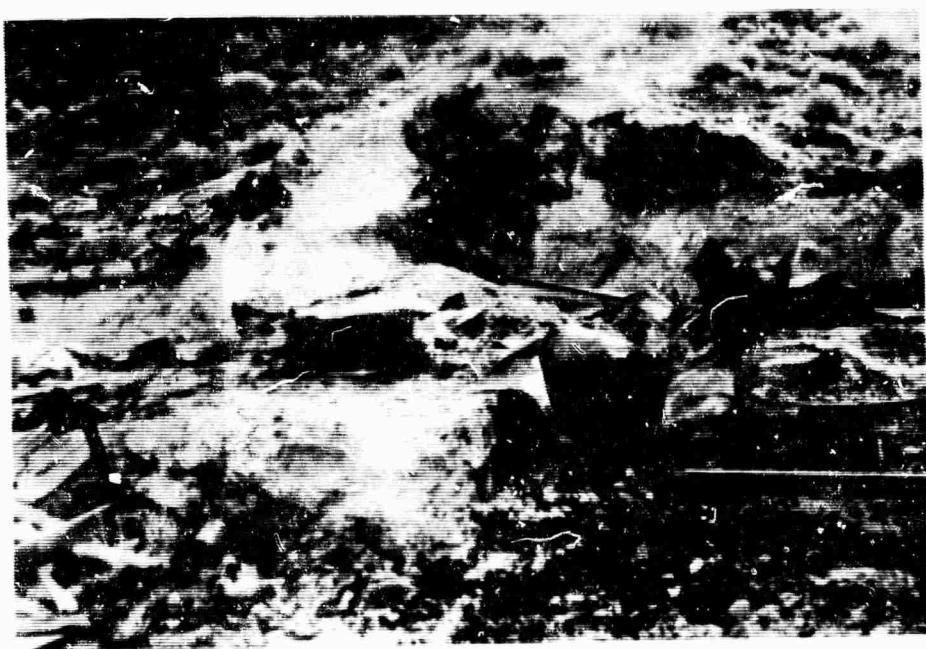
Photo No. 10-1 - Preshot - September 30, 1963

10-1 Cabin (See photo 10-1) A cabin which was on the site has recently burned down completely. No damage was noted as a result of the postshot survey.

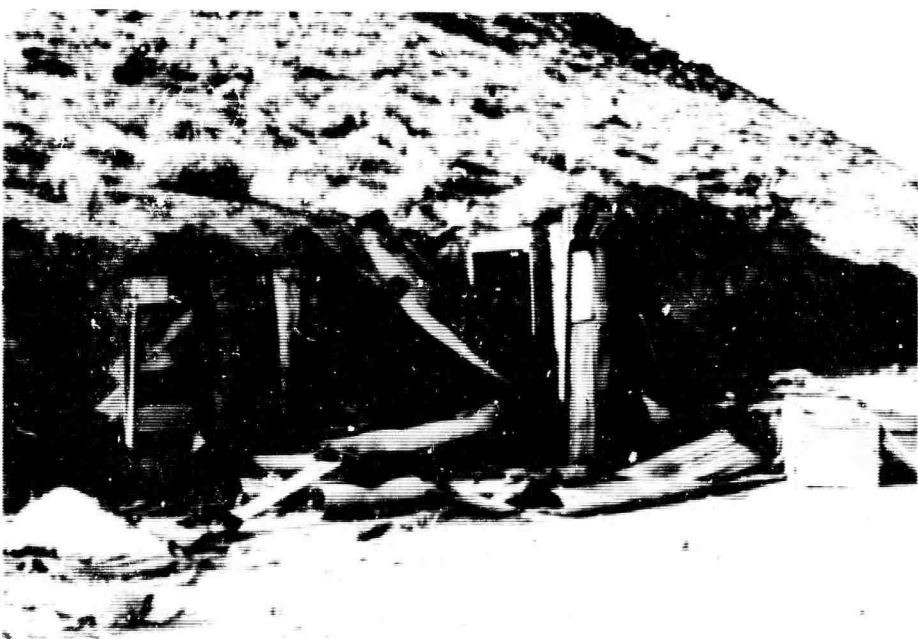
Photo No. 10-2 - Preshot - September 30, 1963

10-2 Cabin (See photo 10-2) Abandoned wrecked cabin. Roof is completely missing and most of the walls have collapsed. No damage was noted as a result of the postshot survey.

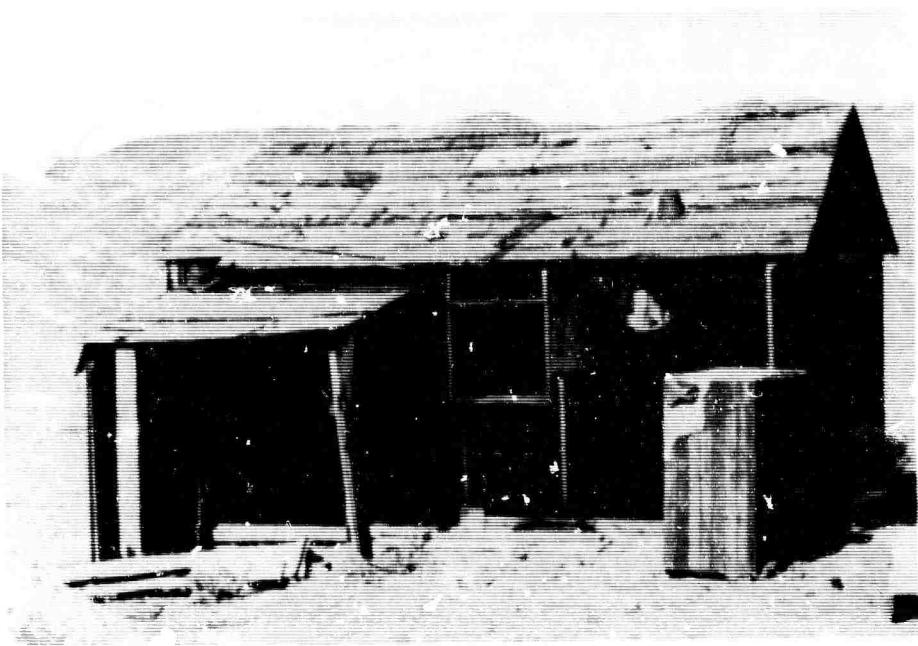
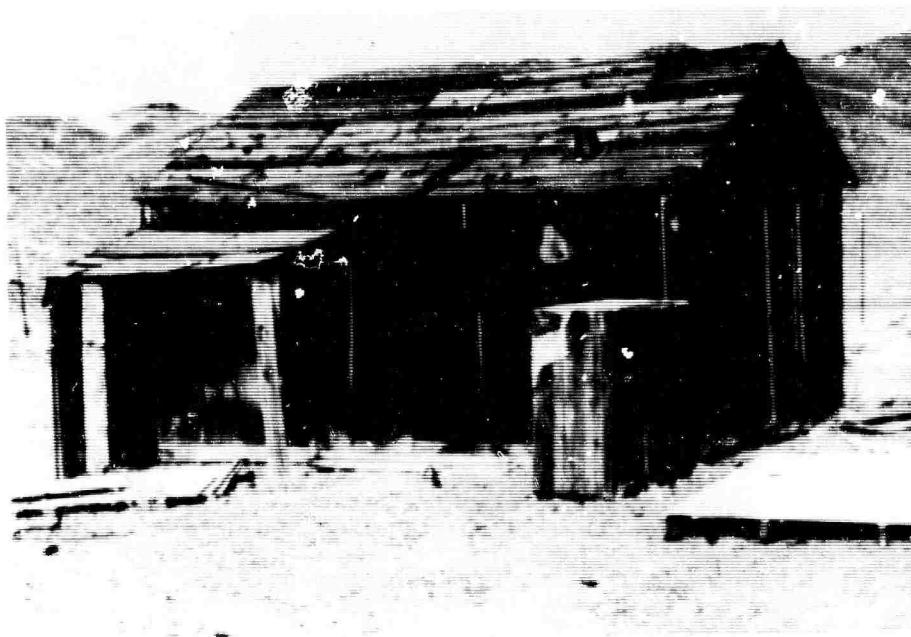
Photo No. 10-3 - Preshot - September 30, 1963

10-3 Shack (See photo 10-3) This 16 x 20-foot shack is abandoned. Wood frame and wood and roofing felt covered, generally in dilapidated condition. Roof covering is entirely gone. Windows are missing, boards are warped and the roof structure sags. No damage was noted as a result of the postshot survey.

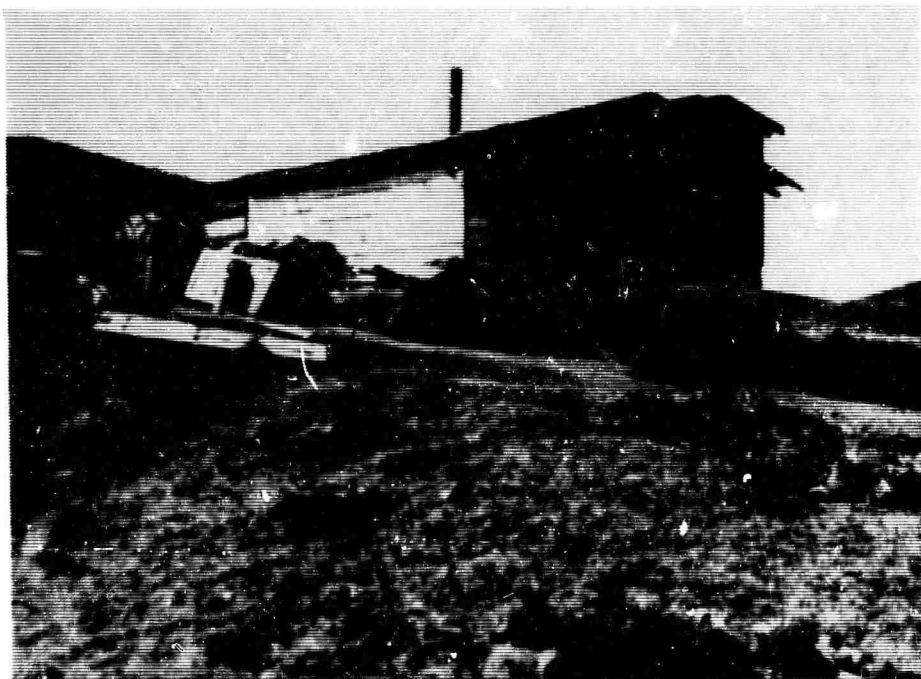
Photo No. 12-1 - Preshot - September 30, 1963

12-1 Cabin (See photo 12-1) This is a 24 x 24-foot wood frame and wood siding occupied cabin. AZ 170° clockwise from magnetic north. No damage was noted as a result of the postshot survey.

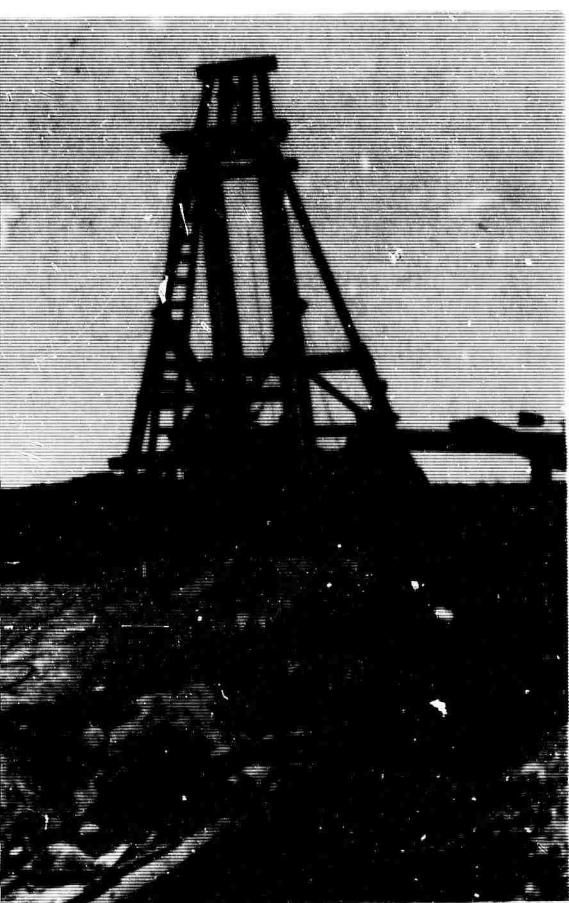
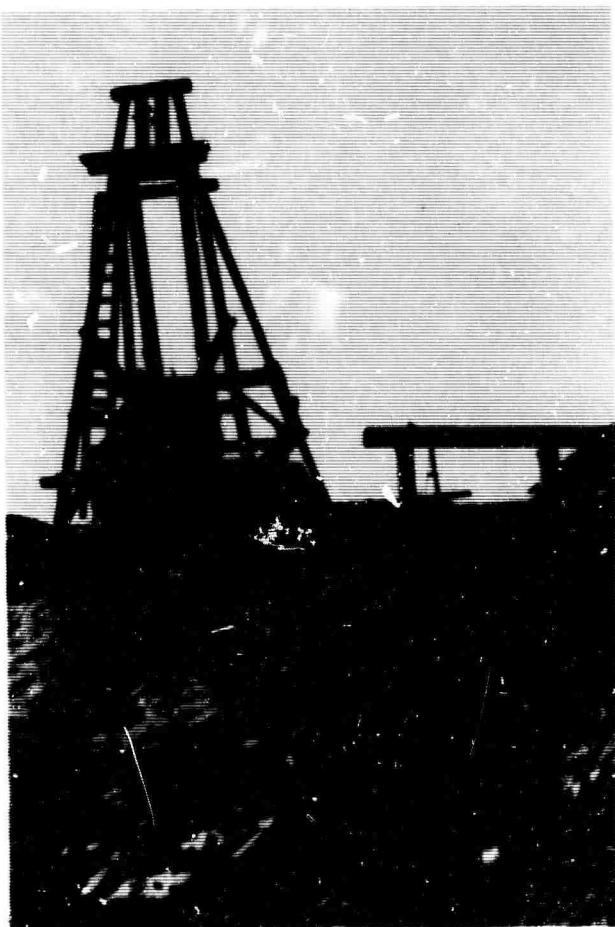
Photo No. 12-2

12-2 Headframe (See photo 12-2) Headframe structure of wood in good usable condition. No damage was noted as a result of the postshot survey.

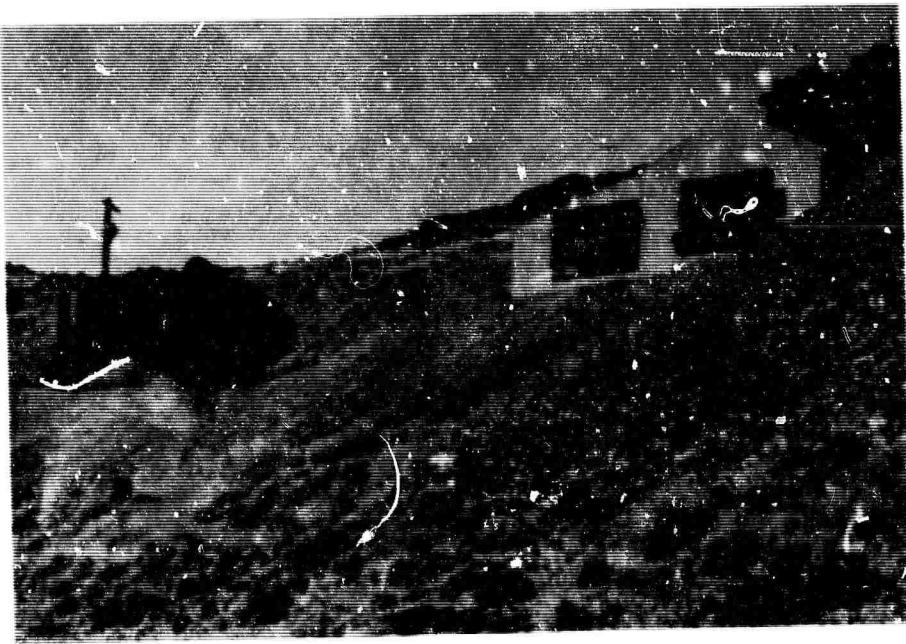
Photo No. 13-4 - Preshot - September 30, 1963

13-4 Shed (See photo 13-4) This is a 20 x 30-foot building of wood frame and corrugated metal siding. Windows are boarded over but glass is generally broken. No damage was noted as a result of the postshot survey.

13-5 Shed (See photo 13-4) This is a 10 x 20-foot wood dilapidated shed. Siding is unpainted, weather beaten and warped. Windows and doors are missing. No damage was noted as a result of the postshot survey.

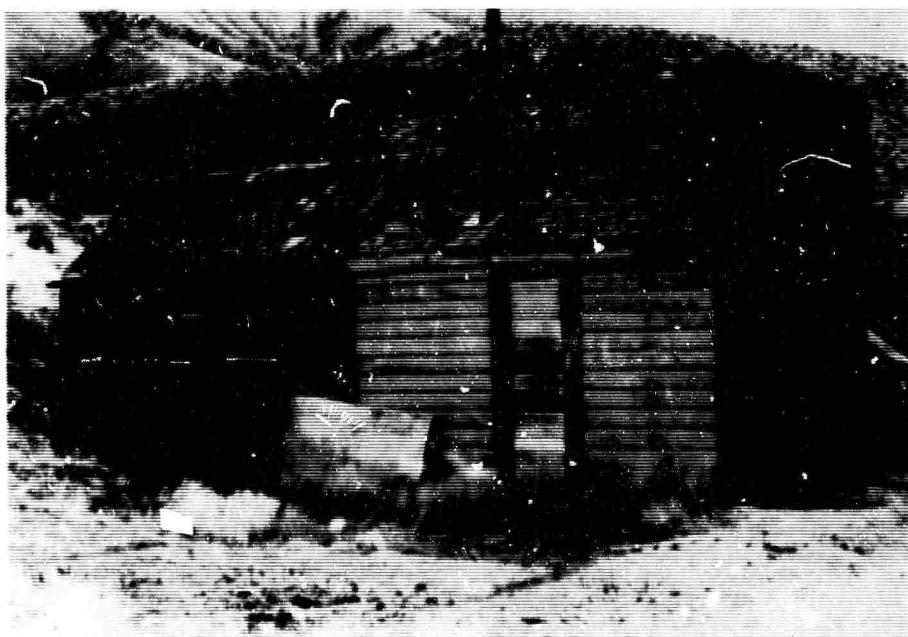
Photo No. 13-7 - Preshot - September 30, 1963

13-7 Store Building (See photo 13-7) This 12 x 24-foot store building is wood frame and siding with wood shingle roof. Doors and windows are missing. Several holes exist in the roof. Siding is weather-beaten and curled. No damage was noted as a result of the postshot survey.

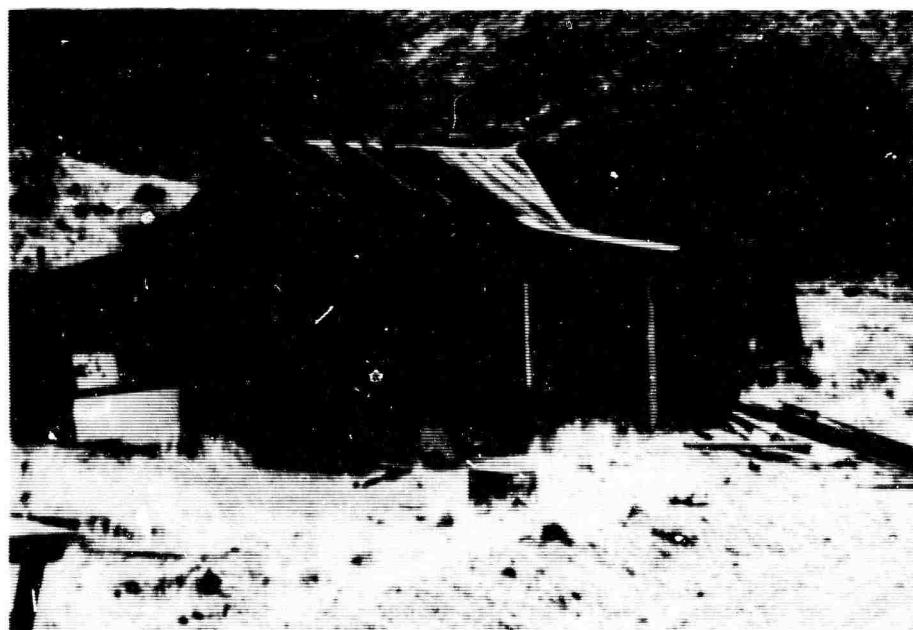
Photo No. 13-8 - Preshot - September 30, 1963

13-8 House (See photo 13-8) This 20 x 30-foot house is wood frame and siding. Doors and windows are missing. Generally dilapidated. No damage was noted as a result of the postshot survey.

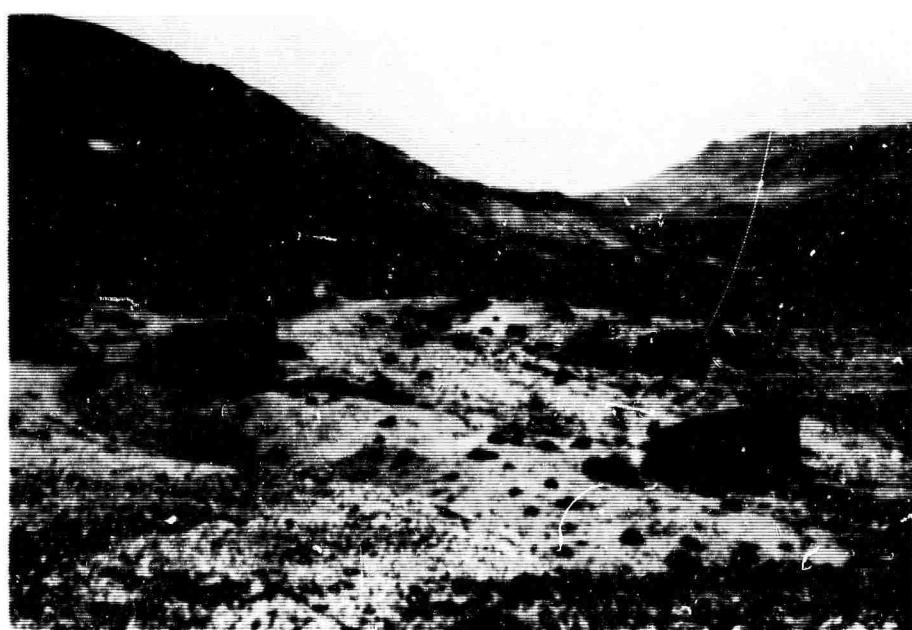
Photo No. 14-2 - Preshot - September 30, 1963

14-2 Cabin (See photo 14-2) This is a 16 x 16-foot abandoned cabin. Wood frame and siding, wood shingle roof partly missing. No damage was noted as a result of the postshot survey.

14-3 Cabin (See photo 14-2) This is a 16 x 16-foot abandoned cabin. Wood frame and siding, wood shingle roof partly missing. No damage was noted as a result of the postshot survey.

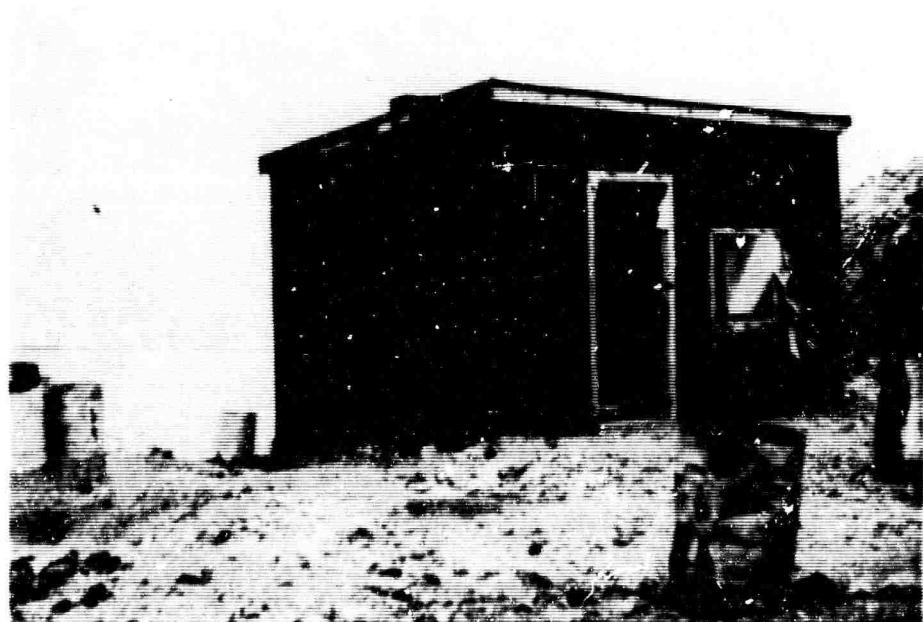
Photo No. 15-2 - Preshot - September 30, 1963

15-2 Shack (See photo 15-2) This is an 8 x 15-foot wood frame shack covered with roll roofing on roof and sides. Door and window missing. No damage was noted as a result of the post-shot survey.

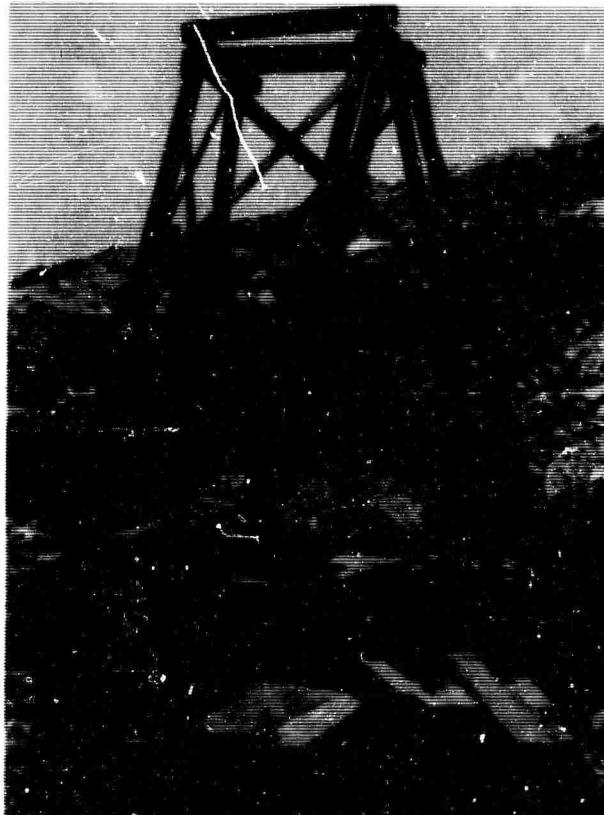
Photo No. 15-3

15-3 Headframe (See photo 15-3) Headframe structure of wood somewhat weathered. No damage was noted as a result of the postshot survey.

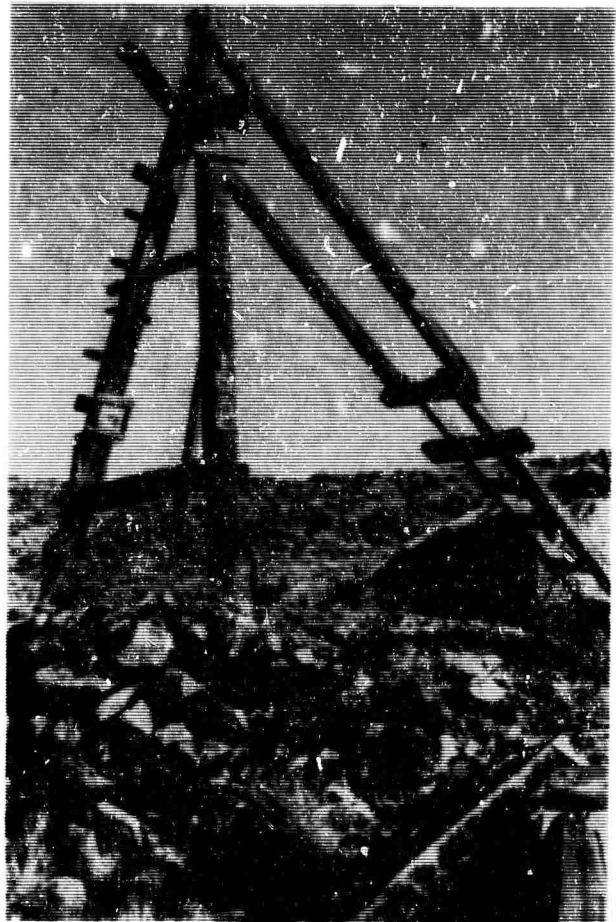
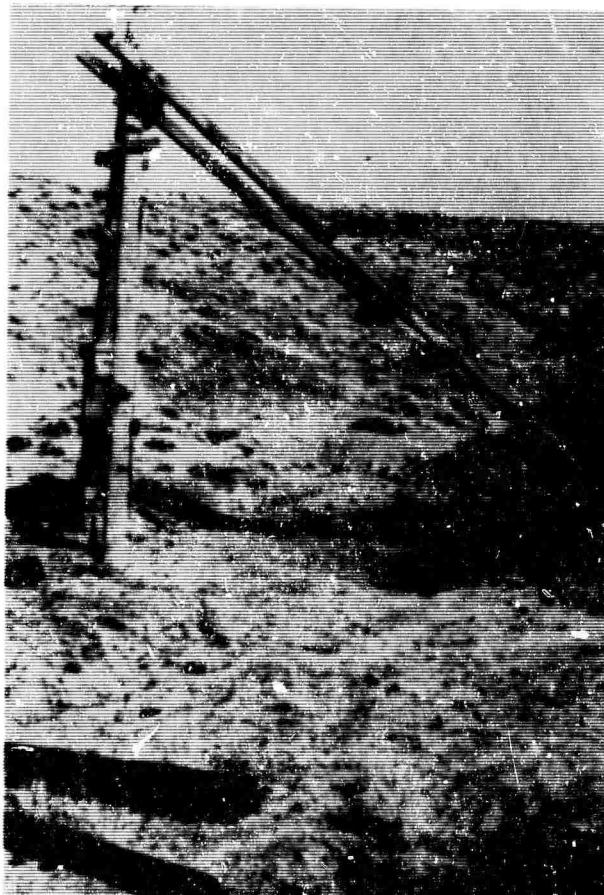
Photo No. 16-2

16-2 West Shaft (See photo 16-2) Wooden headframe structure is the only structure on this site. No damage was noted as a result of the postshot survey.

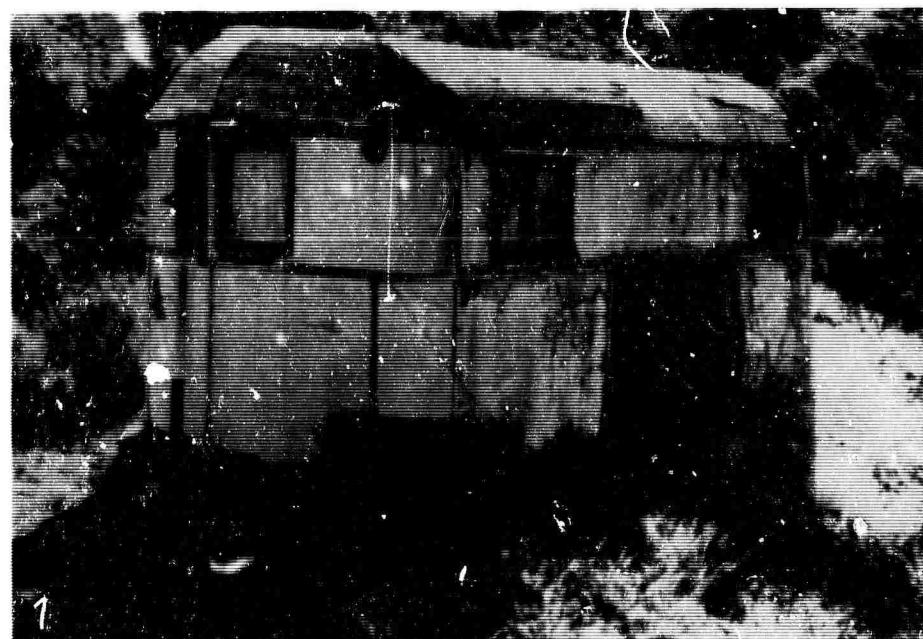
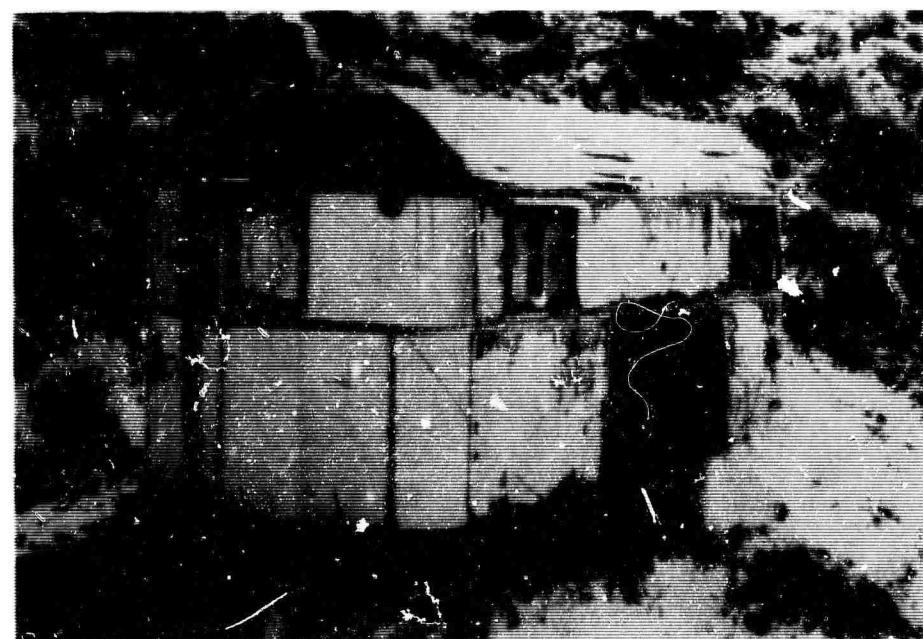
Photo No. 17-1 - Preshot - October 1, 1963

17-1 Trailer (See photo 17-1) Abandoned 16-foot trailer, dilapidated and unoccupied. No damage was noted as a result of the postshot survey.

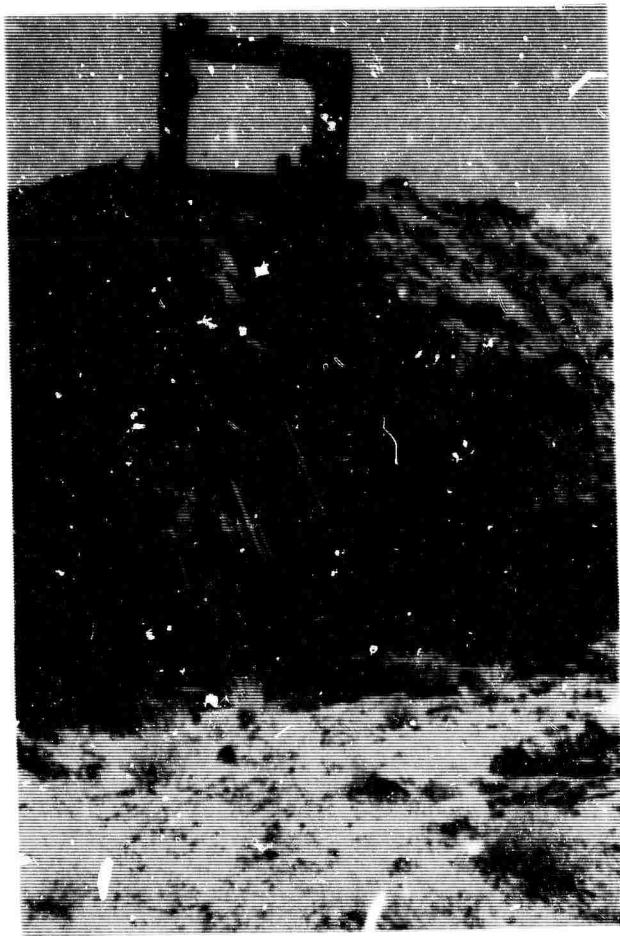
Photo No. 17-2

17-2 Headframe (See photo 17-2) Wooden headframe structure, weather-beaten. No damage was noted as a result of the post-shot survey.

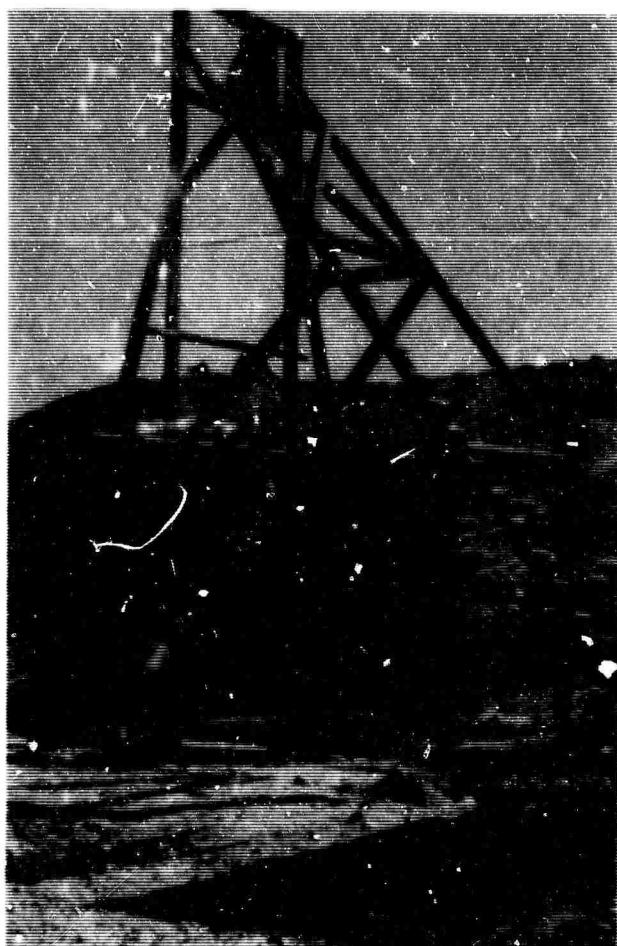
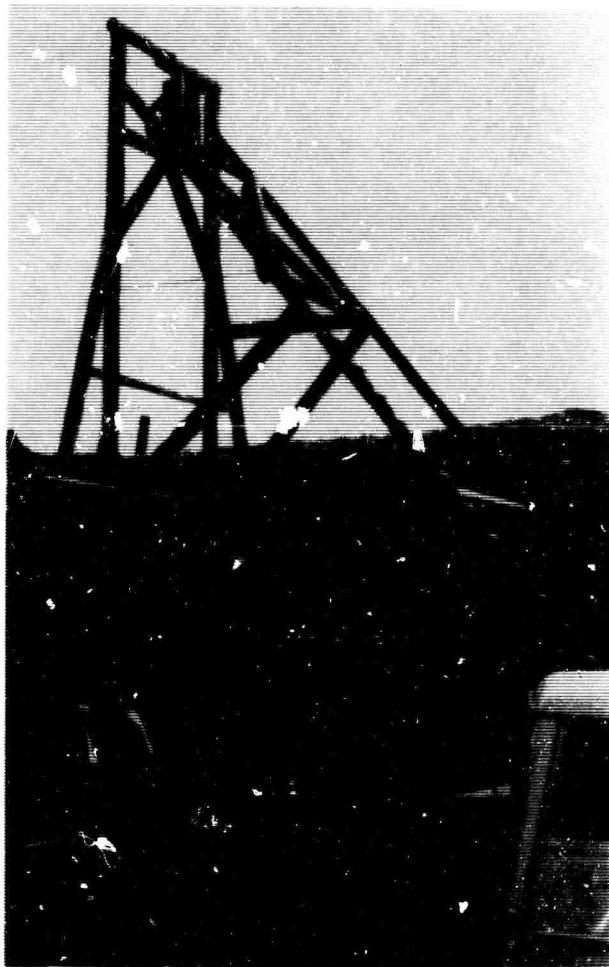
Photo No. 20-1

20-1 Headframe (See photo 20-1) This lower level wood headframe is weathered but otherwise in fair condition. No damage was noted as a result of the postshot survey.

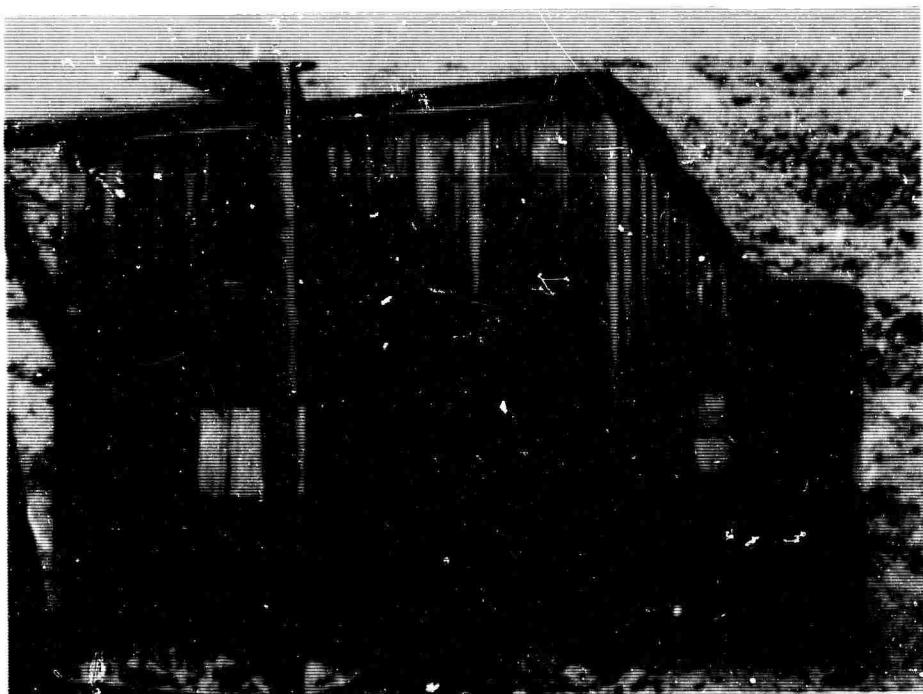
Photo No. 20-2 - Postshot - October 30, 1963

20-2 Hoist House (See photo 20-2) Lower level hoist house. Wood frame and siding, and corrugated metal roof. Siding weather-beaten, and doors and windows missing. No damage was noted as a result of the postshot survey.

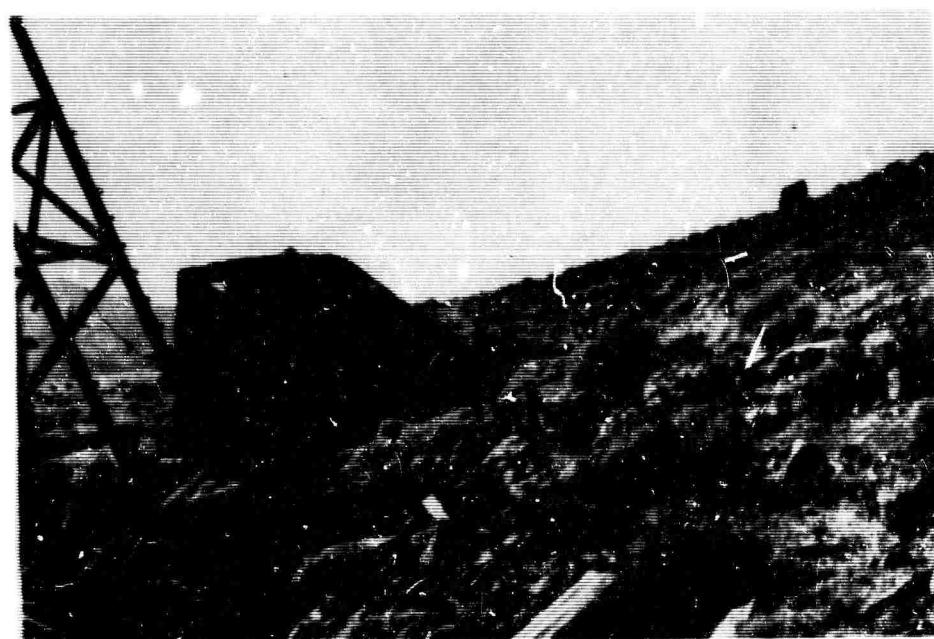
Photo No. 20-5 - Preshot - October 1, 1963

20-5 Hoist House (See photo 20-5) Upper level hoist house. 15 x 30-foot wood structure with corrugated metal roof partly missing. Doors and windows missing. No damage was noted as a result of the postshot survey.

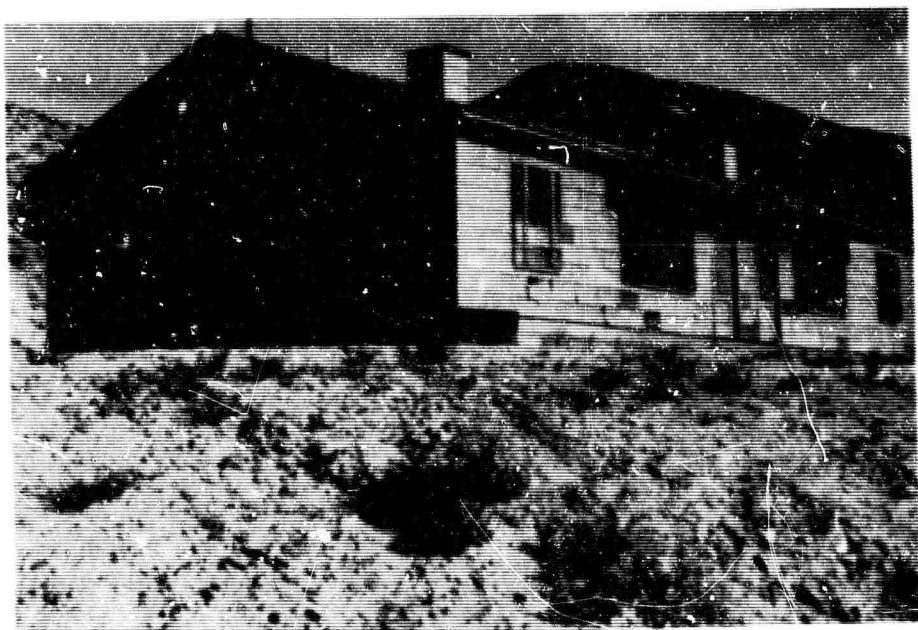
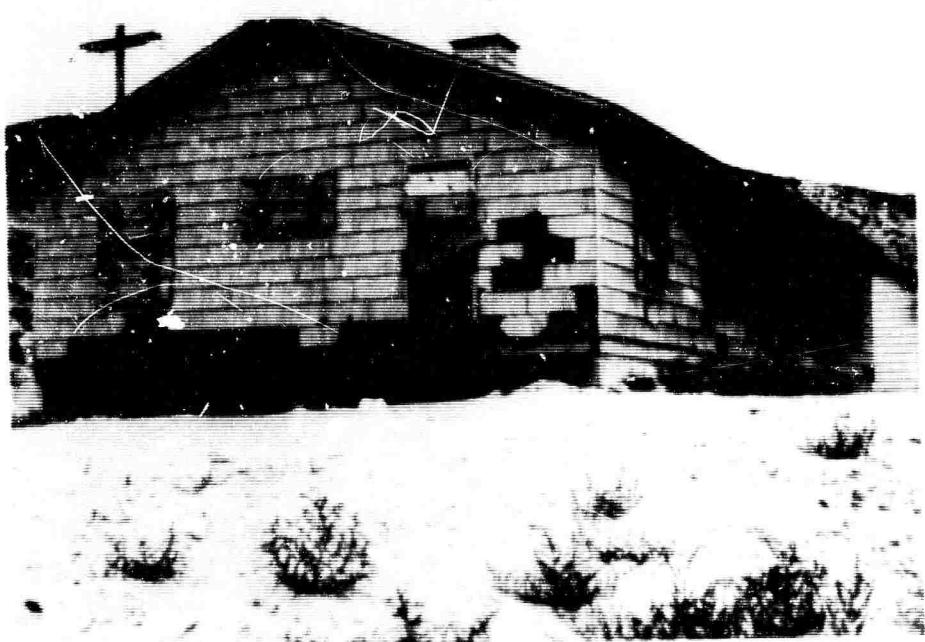
Photo No. 21-1 - Preshot - October 8, 1963

21-1 Residence (See photo 21-1) This structure is wood frame, asbestos shingle covered. Size is about 27 x 55 feet. AZ 295° clockwise from magnetic north. This has been recently moved to this site and is now in the process of being renewed inside and out. No damage was noted as a result of the postshot survey.

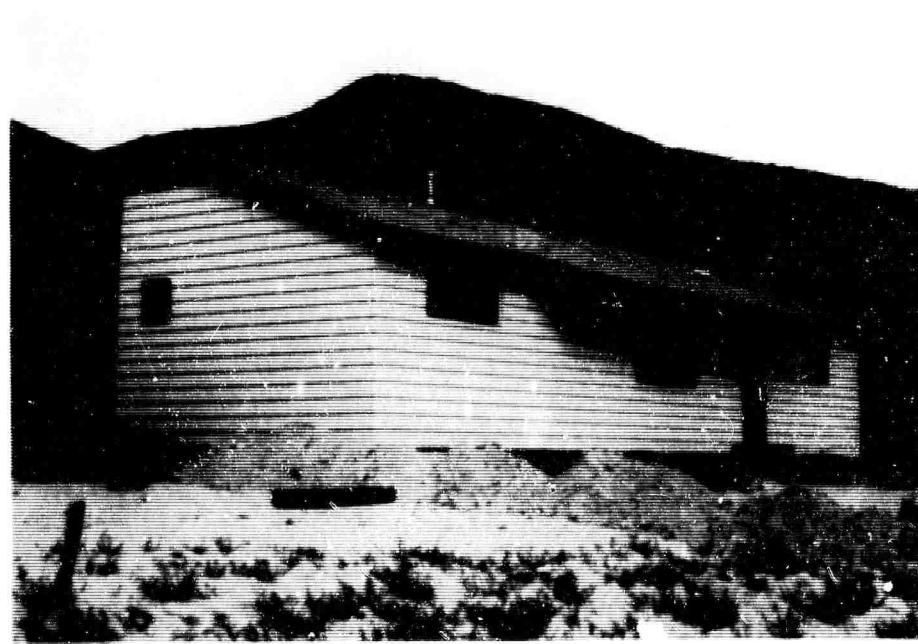
Photo No. 21-2 - Preshot - October 2, 1963

21-2 Residence (See photo 21-2) This is a wood frame, aluminum siding covered structure. Size is 27 x 55 feet. AZ 295° clockwise from magnetic north. This structure has been recently
